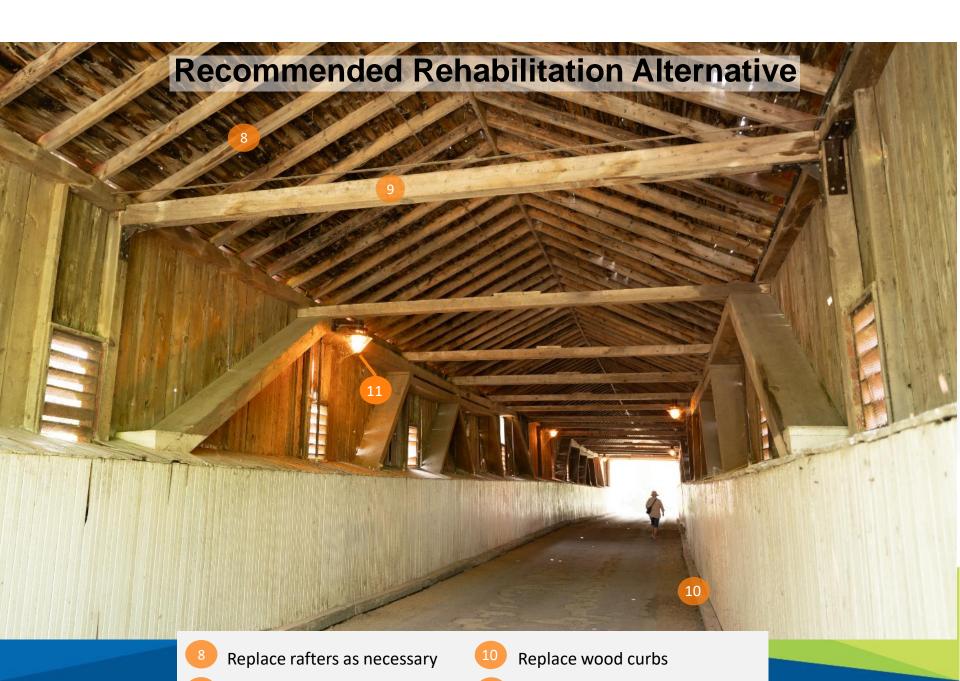
Replace light bulbs as necessary

Replace tie beams as necessary

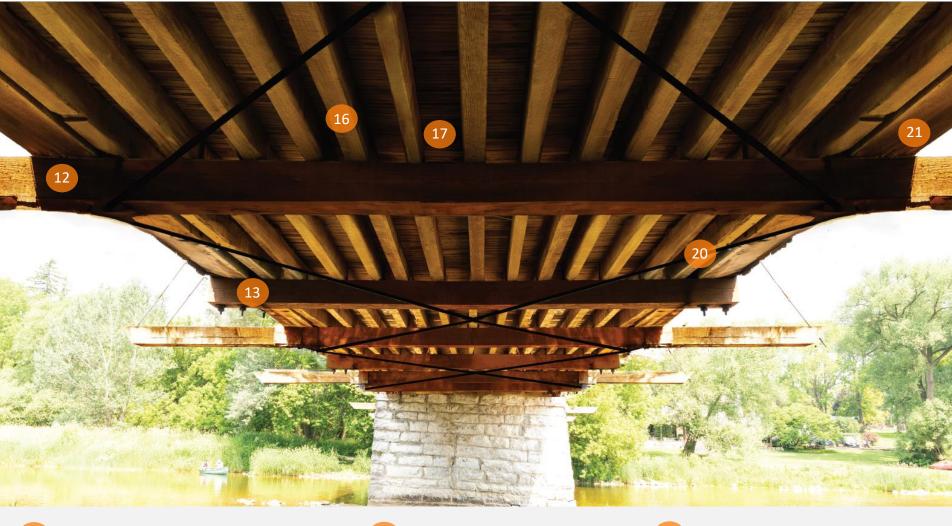
- 12 New Douglas Fir 16"x16" needle beams
 - eams
- New sawn wood stringers
- New steel rod cross-bracing

- 13 New Douglas Fir 16"x16" floor beams
- 17 New nail-laminated wood deck
- 21 New Douglas Fir bottom chords

- Concrete repairs to bridge abutments
- 23 Bridge deck elevation and approach grades will remain the same
- 24 Height restriction bar to prevent oversized vehicles from using the bridge
- 25 Fire retardant materials applied to various bridge elements

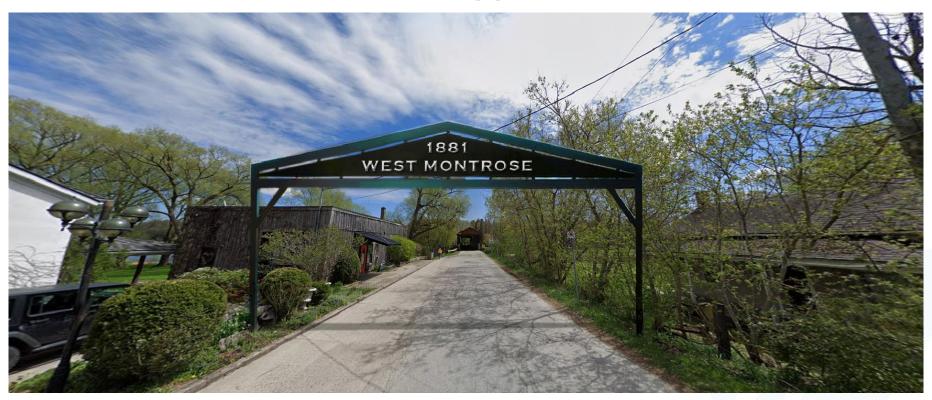
Height Restriction Bar - North Approach

*Details to be finalized with the input of an architect

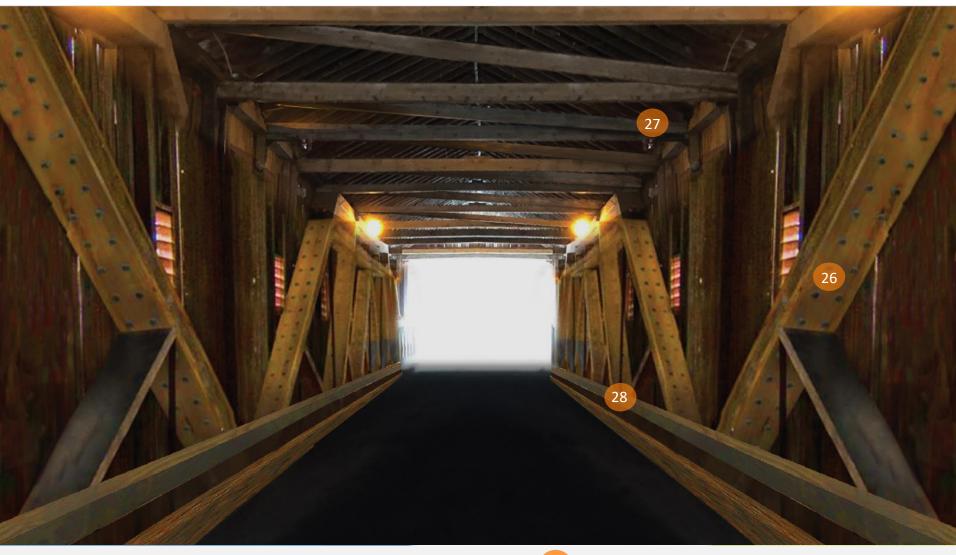
Replace end diagonals at pier and strengthen end diagonals at abutments

27 New overhead wood lateral bracing

New timber guiderail

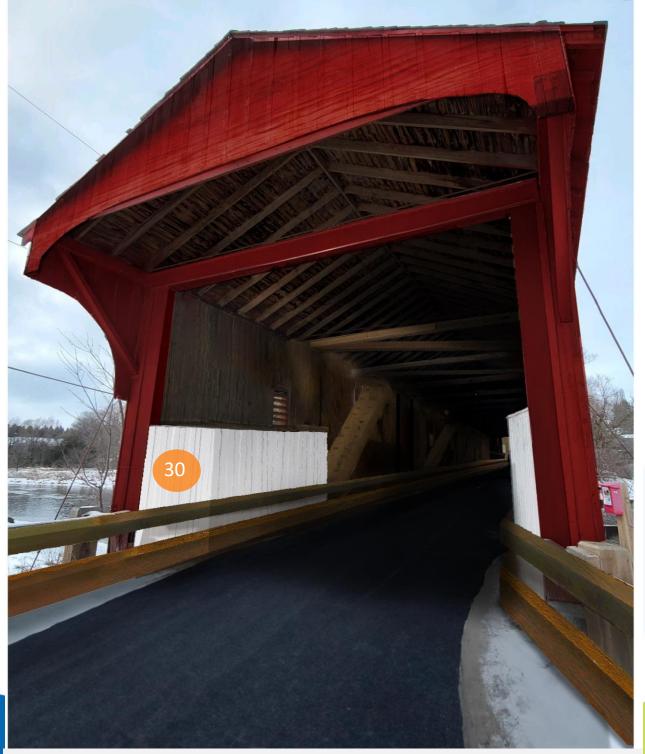
Reinstate interior cladding in short sections at each end of the bridge
